ODOR ASSESSMENT

**Lunenburg High School
Kitchen Area
1079 Massachusetts Avenue
Lunenburg, MA**

Prepared by:
Massachusetts Department of Public Health
Bureau of Environmental Health
Indoor Air Quality Program
May 2019

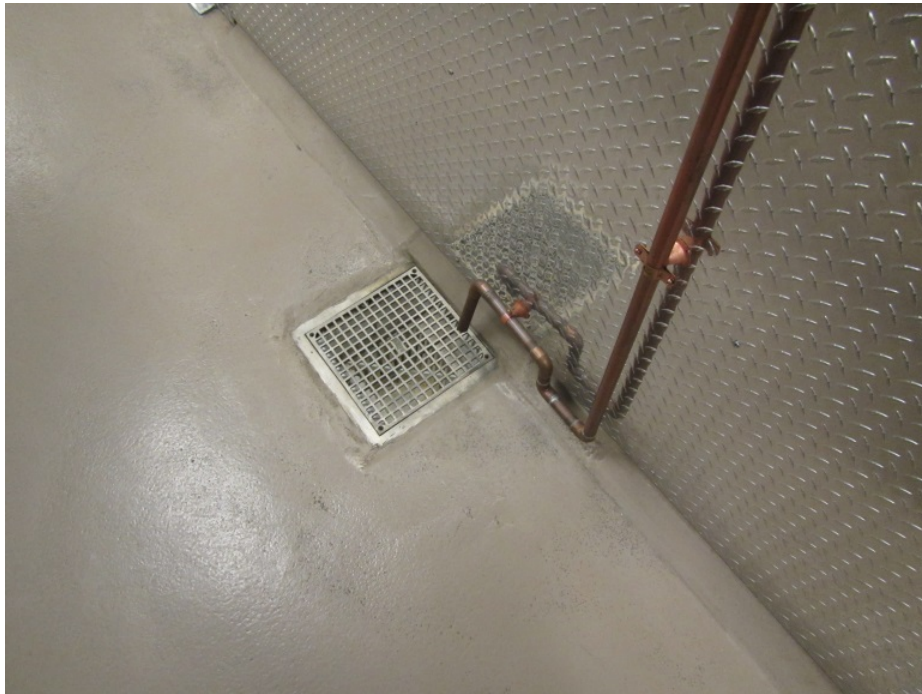
Picture 1

Of note was the existence of a floor drain in front of the refrigerator (Picture 1) which likely has a dry drain trap. In addition a second floor drain exists beneath an unused steamer (Picture 2) The purpose of a drain trap is to inhibit the draw of sewer gas, odors and other pollutants from the drain system. With an operating kitchen hood, pollutants from the drain system can be drawn into the kitchen.

Floor drain in front of refrigerators

1. Ensure that floor drains in the kitchen are wetted with a sufficient amount of water daily.
2. For buildings in New England, periods of low relative humidity during the winter are often unavoidable. Therefore, scrupulous cleaning practices should be adopted to minimize common indoor air contaminants whose irritant effects can be enhanced when the relative humidity is low. To control dusts, a high efficiency particulate arrestance (HEPA) filter equipped vacuum cleaner in conjunction with wet wiping of all surfaces is recommended. Avoid the use of feather dusters. Drinking water during the day can help ease some symptoms associated with a dry environment (throat and sinus irritations).

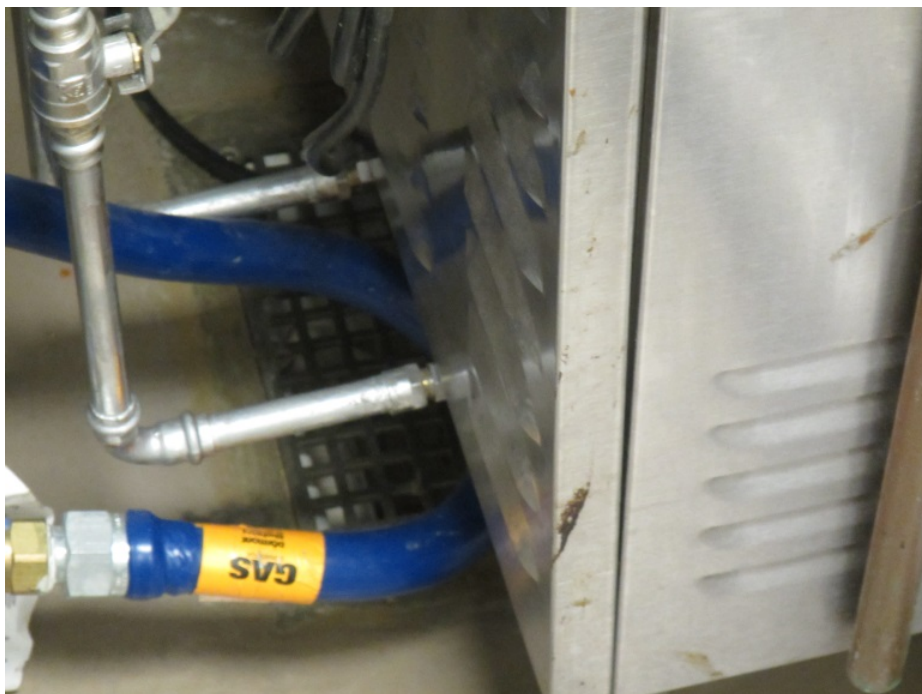
Picture 2

Floor drain beneath steamer
